INSPECTION REPORT

RCRA Subtitle C

Brenntag Northeast Inc.

July 29-30, 2014

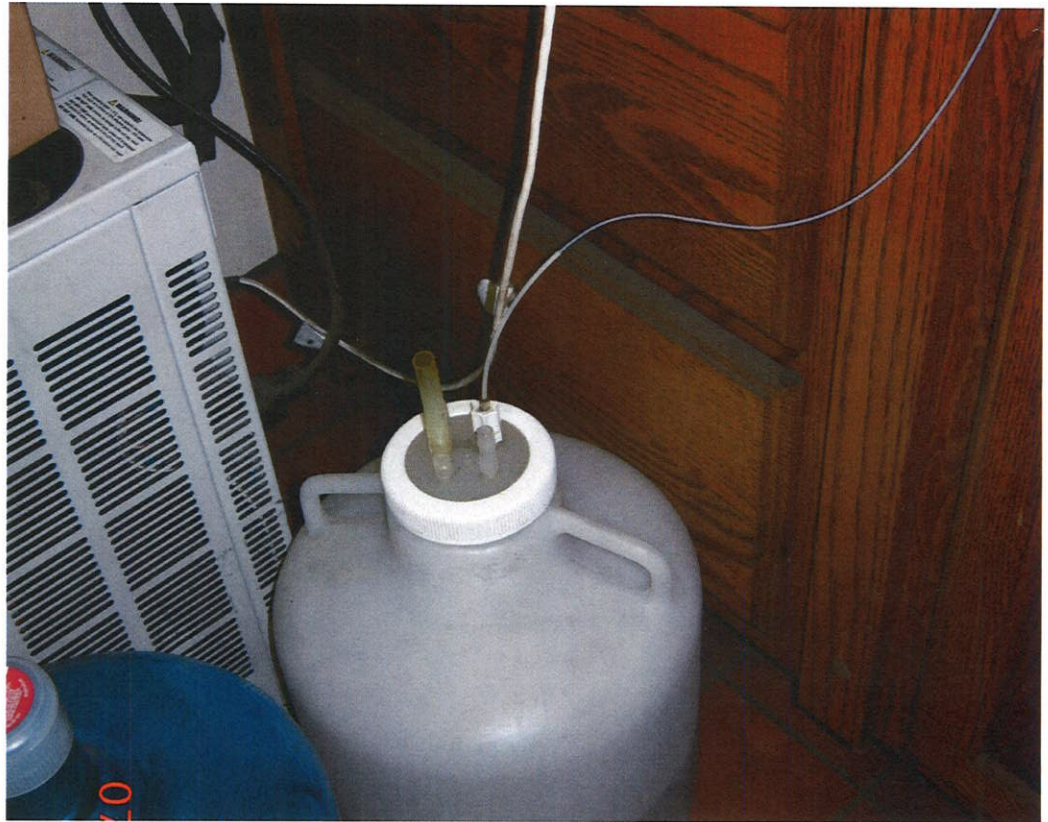
Photograph #1

The inspection of the facility began in the Brenntag laboratory where a variety of chemical testing by lab personnel occurs on a daily basis. The inspectors observed several containers of waste in this area that were not labeled as hazardous waste (**Photograph #1**). These bottles were waste chemicals from the nearby liquid chromatograph machines. One bottle was described by facility staff as KB waste, which is an abbreviation for a Kauri butanol waste solution. Another waste bottle was described as KF waste solution. There wasn't any larger 55-gallon drums nearby for collection and storage of these wastes in the laboratory. Facility staff told the inspectors that these liquid wastes were taken to another part of the facility for disposal.

These two containers was collecting waste in the lab room from a nearby liquid chromatograph machine. Neither was labeled as hazardous waste.

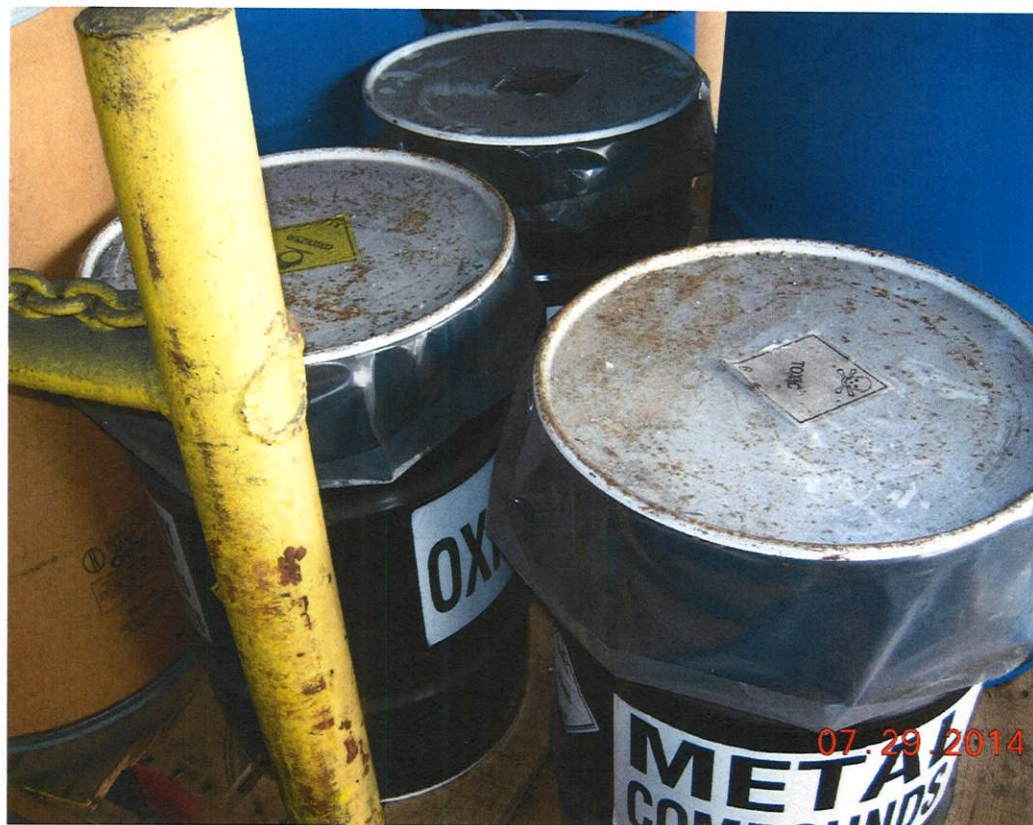
Photograph #2

Drums located at side of loading/unloading area marked metal compounds, etc. These drums were not labeled as hazardous waste and the lids were not secured.

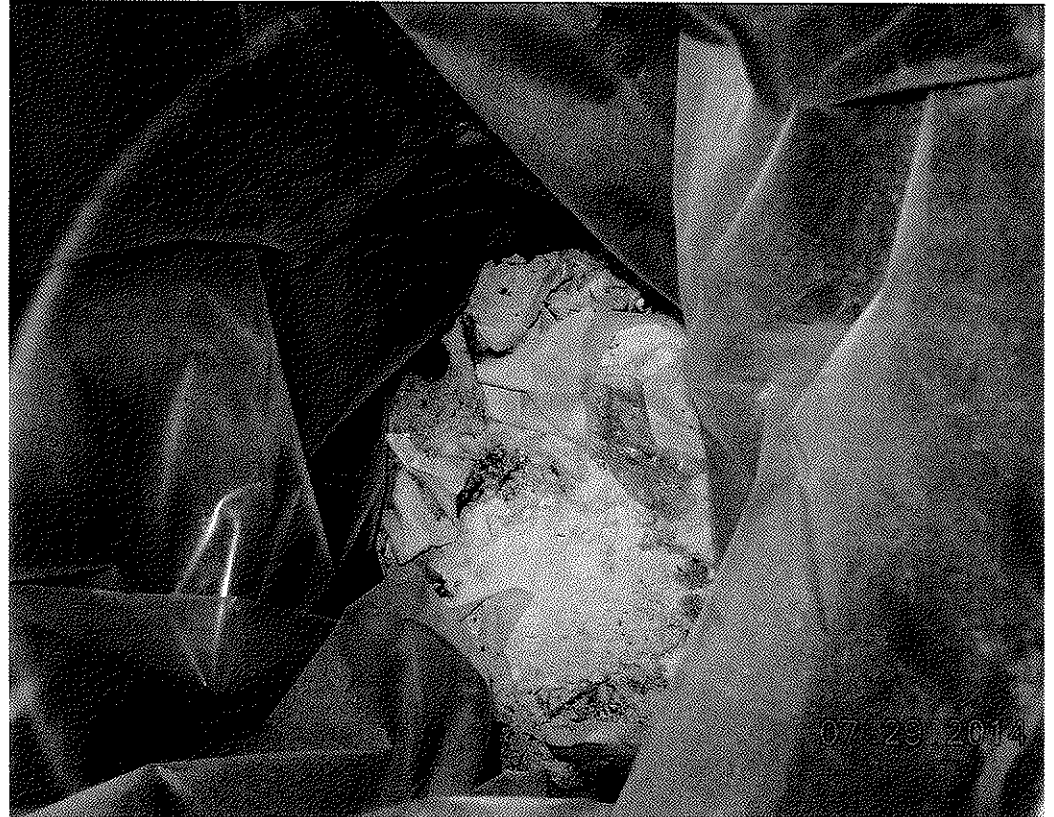
Photograph #3

This is the contents of the drum shown in Photograph #2, and described as metal compounds. A white solid dust was in the drum at the time of the inspection.

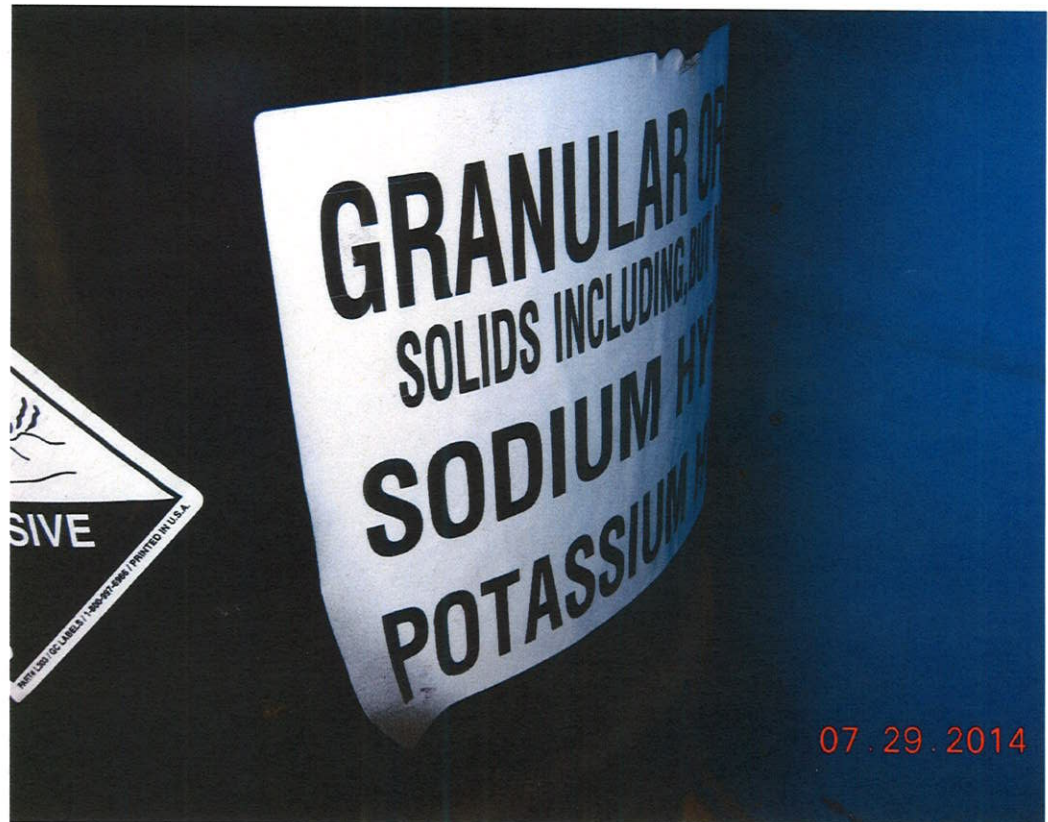
Photograph #4

Drum marked as granular solids including sodium hydroxide & potassium hydroxide. Although it had a corrosive label on it, it was not labeled as hazardous waste.

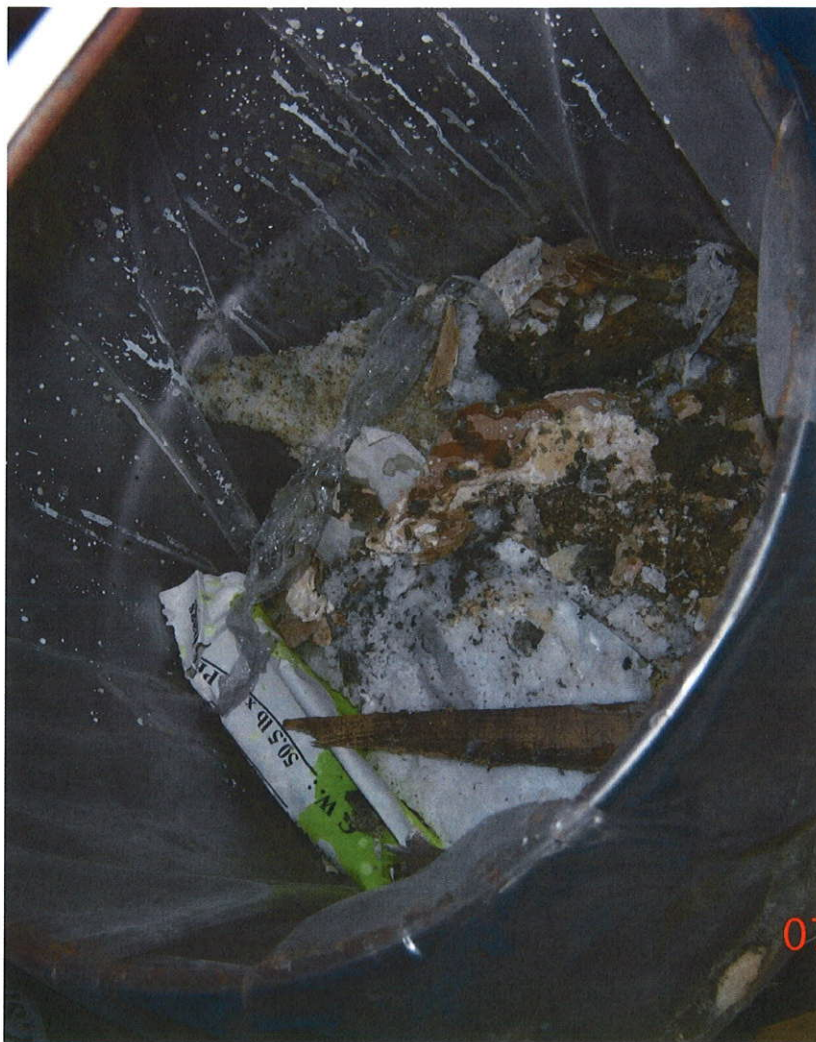
Photograph #5

Contents of drum near loading area that was not labeled as hazardous waste.

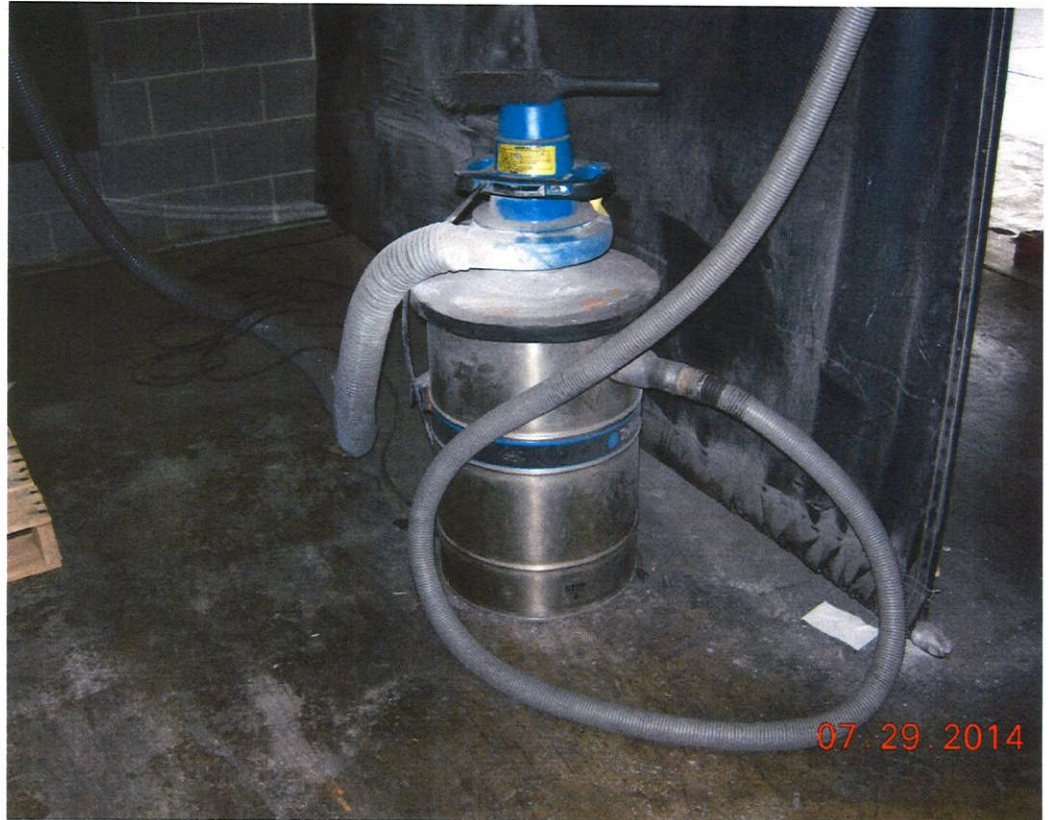
Photograph #6

The tour then continued to the facility's loading area. Off to the side of the loading area was a clean-up area that was called the trash zone, or the sweep collection area, by facility staff. Waste was generated in this area as trucks were cleaned out or containers of product were broken in the loading/unloading process. There were three drums without hazardous waste labels and lacking secure lids in this area, one drum was marked as "Metal Compounds" (**Photograph #2**). Facility staff opened this drum, and a solid waste was visible inside it (**Photograph #3**). Another one of the drums was marked as "granular solids, sodium hydroxide and potassium hydroxide" (**Photograph #4**), and that drum also was shown to contain a solid white waste (**Photograph #5**). In that same area, a Shop-Vac vacuum cleaner was being used to vacuum up hazardous waste dust that was accumulating from the loading area (**Photograph #6**). Facility

The Shop-Vac located as the side of the loading area, and described as the sweep collection zone. The Shop-Vac was not labeled as hazardous waste.

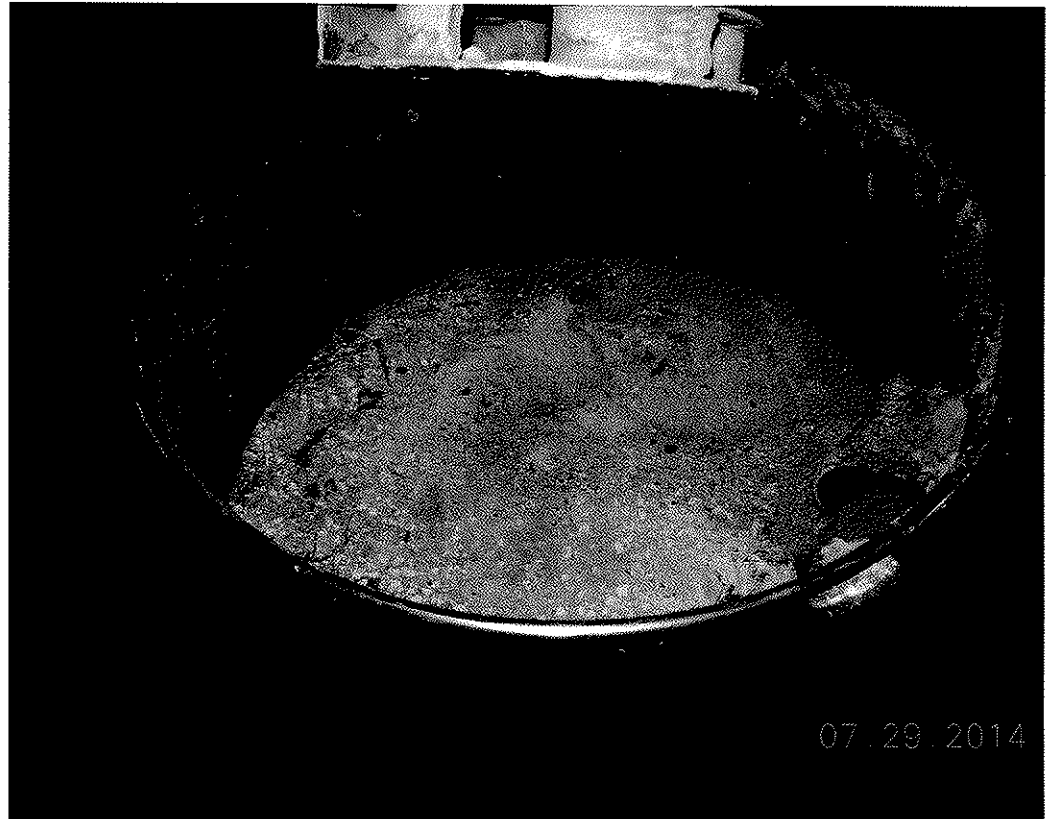
Photograph #7

staff opened this unit up, and the inspectors took a picture of its contents (**Photograph #7**). The Shop-Vac unit was not labeled as containing a hazardous waste, and facility staff were not certain about how the waste inside the Shop-Vac was subsequently managed.

Facility staff opened the Shop-Vac for the EPA inspectors, and this photograph shows the contents of the machine. It was not labelled as hazardous waste.

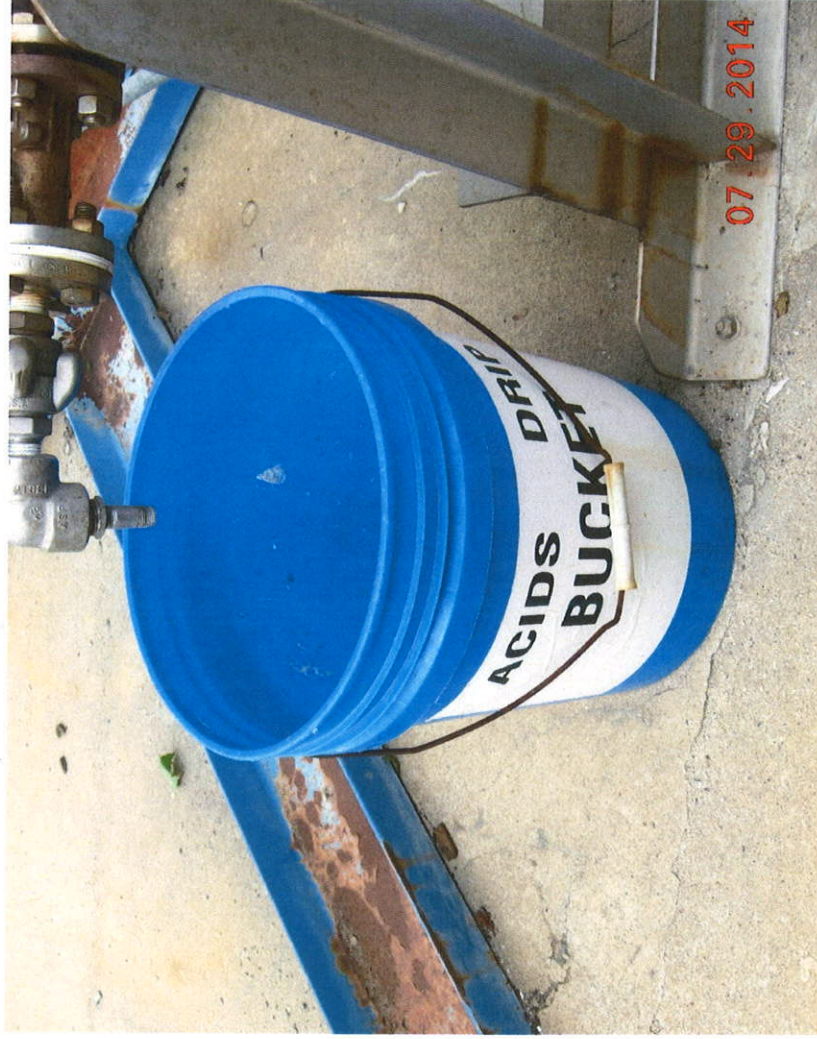
The inspectors walked outside to observe a number of aboveground storage tanks. The inspectors observed a blue bucket marked acids drip bucket (**Photograph #8**) near a large storage tank of acid. The inspectors observed that this blue container had no lid and was not being properly managed as hazardous waste. Inspectors took a photograph of its contents (**Photograph #9**). Nearby were two other drums, essentially drip barrels from a nearby hydrogen peroxide storage tank, these drums were not labeled as hazardous waste or properly closed (**Photograph #10**). A closer view was also taken of this collection process (**Photograph #11**), and a close-up of one of the two drums (**Photograph #12**). As the inspectors walked around the outside area, near the loading rack, a full steel tote was observed. On this tote, the accumulation start date was not legible, it appeared to have been washed off by some of the solvent that it contained (**See Photograph #13**).

Photograph #8
Acids drip bucket from nearby tank.

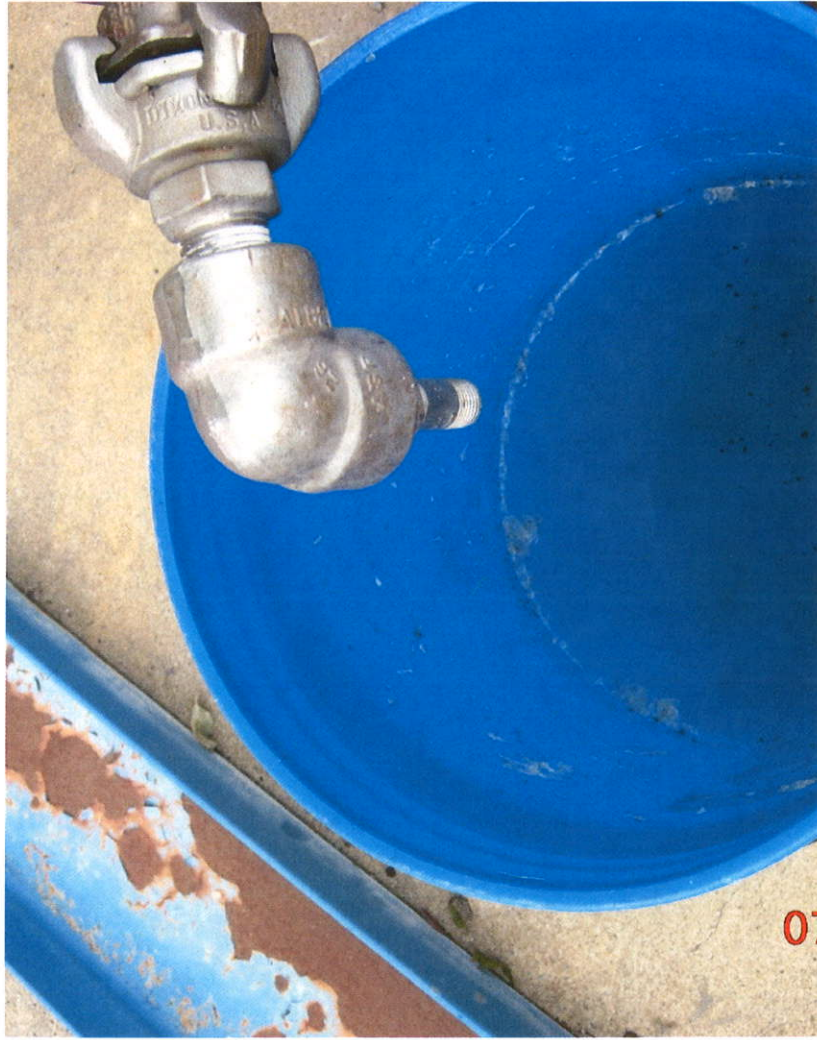
Photograph #9

Contents of acids drip bucket. This bucket did not have a lid or a hazardous waste label.

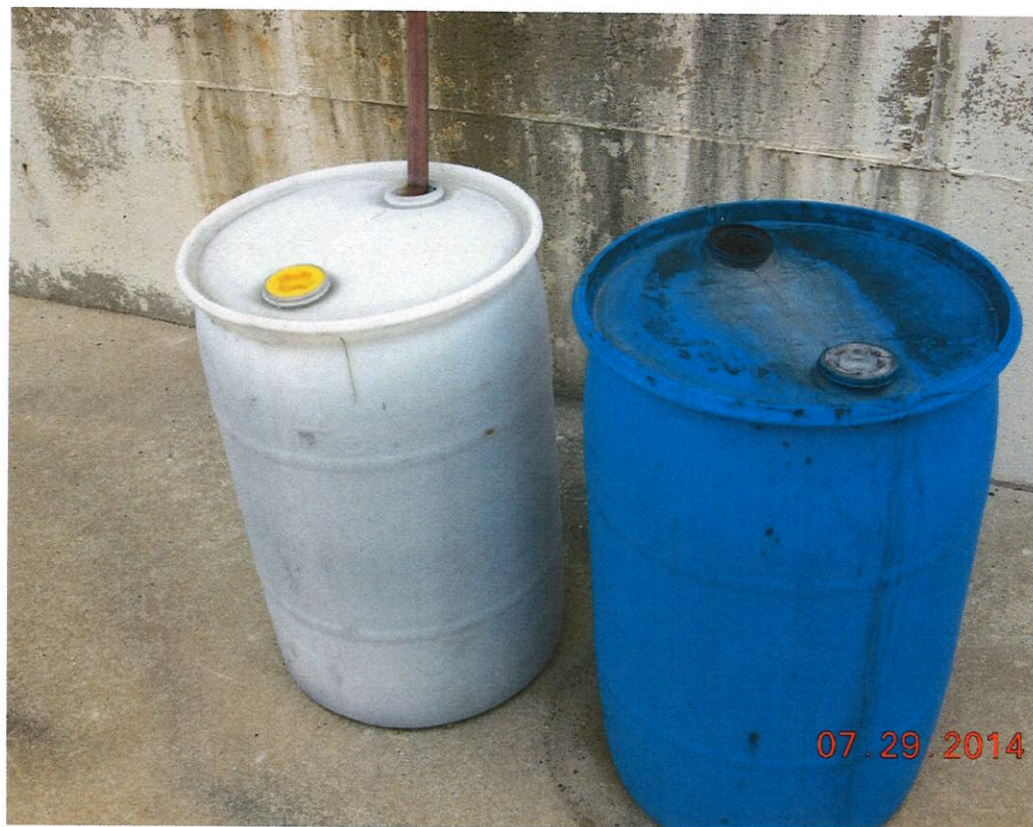
Photograph #10

These drums were receiving waste via the reddish hose coming from a nearby tank of hydrogen peroxide. See Photograph 11 for picture of the tank to drum process.

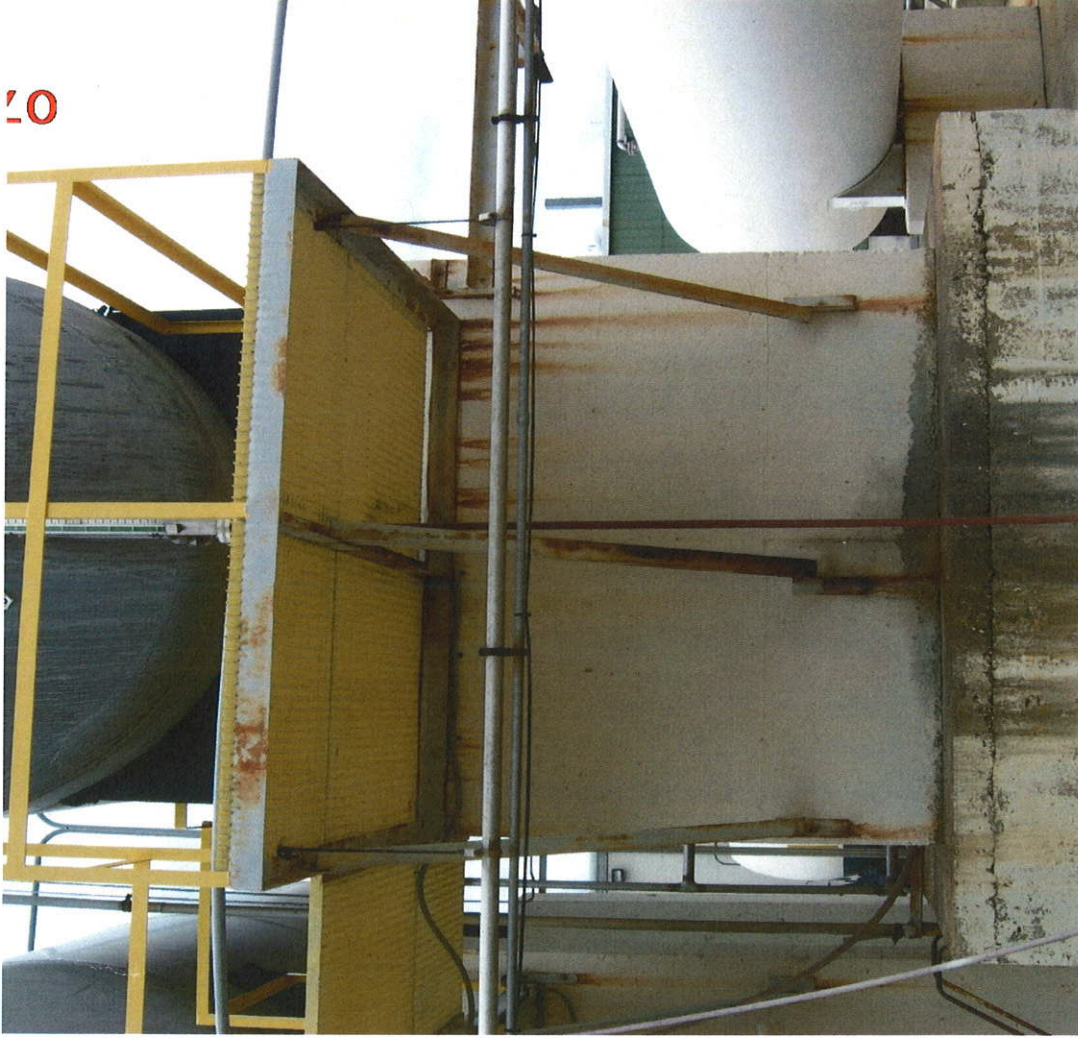
Photograph #11

Gray tank is visible at top, and red hose leads to two drums in Photograph #10.

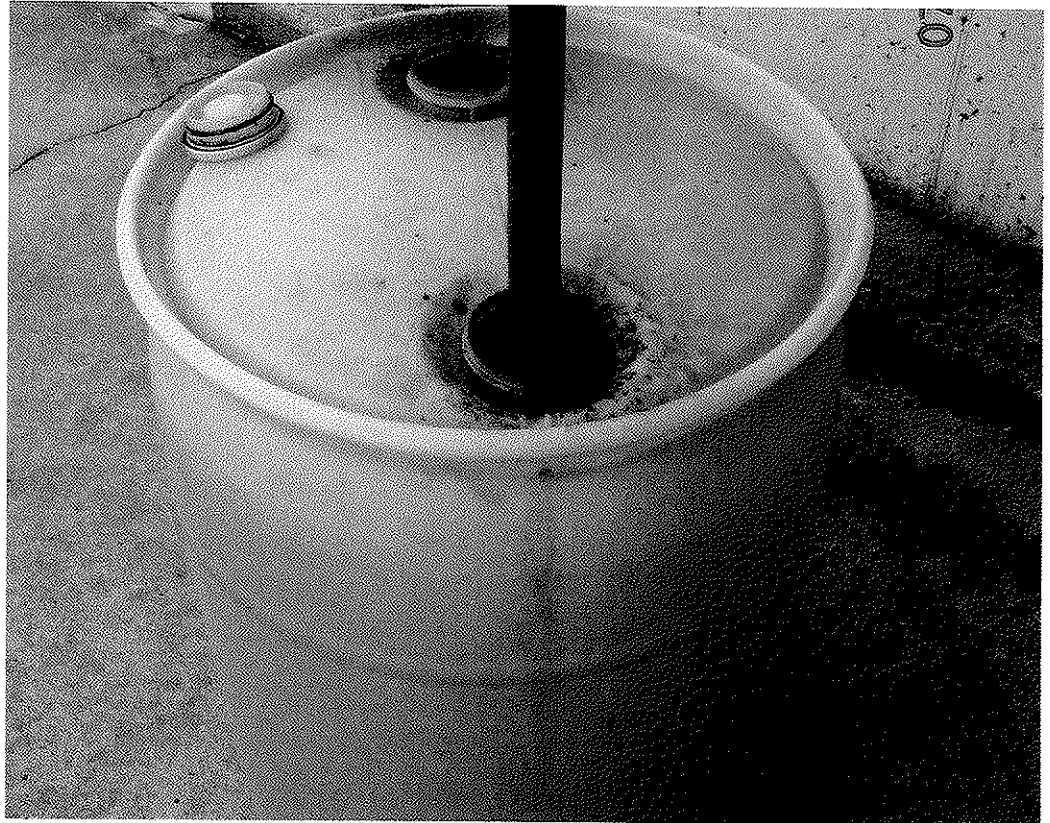
Photograph #12

Close-up photograph of the one drum with hose in it. Notice the drum is almost completely full.

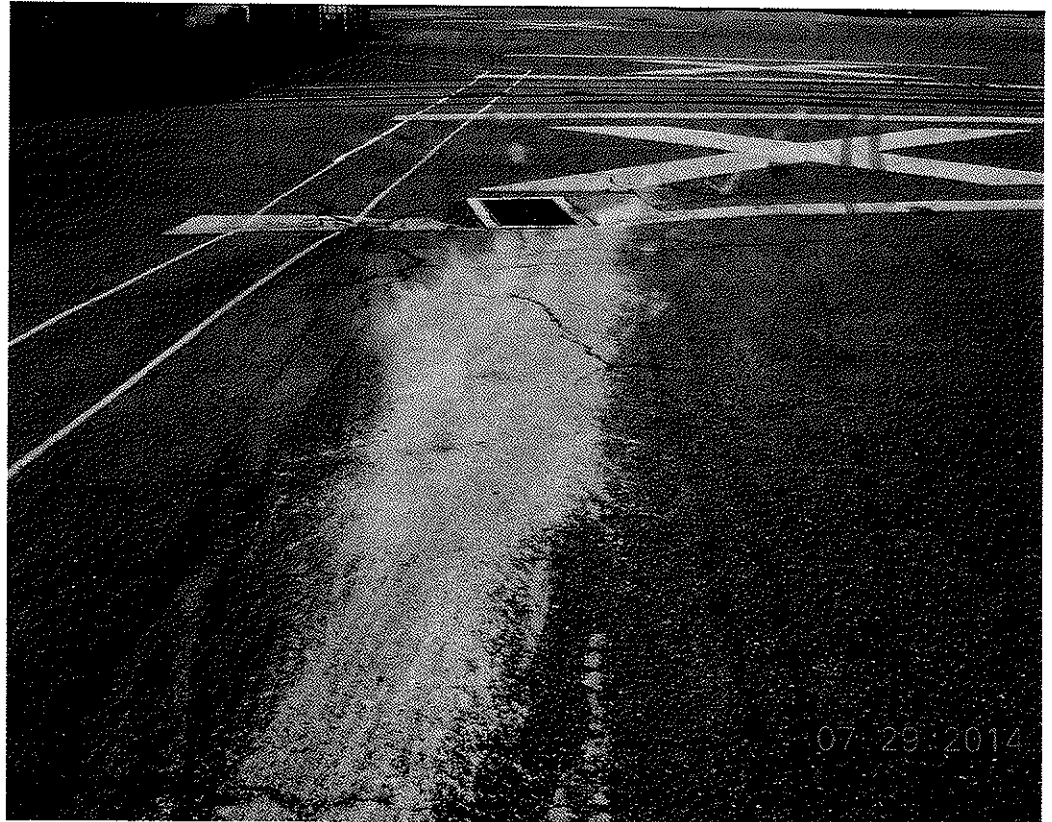
Photograph #14

Inspectors walked towards the rear of the property and observed several spills of different products on to the ground. First, a long stain, about 50 feet in length, of a white substance led directly to one of the storm drains in that area of the facility (**Photograph #14**). A white substance had spilled on to the ground and then washed towards the storm drain. Second, there was an oily spill on the ground near several piles of black drums. The inspectors examined several of the nearby drums, which contained substances such as mineral oil and isobutyl alcohol. These drums may have been the source of this spill (**See Photograph #15 & #16**). In a low area in the rear of the facility, an oily sheen could be seen near a sump area (**Photograph #17**). A second photograph shows the nearby pump utilized to drain this sump area (**Photograph #18**). Finally, a pinkish purplish liquid was leaking on to the ground from a tote of product. Facility staff described the pink liquid as a potassium permanganate solution (**Photograph #19 & 20**).

Spill of a white substance on the ground and flowing directly towards a nearby storm drain.

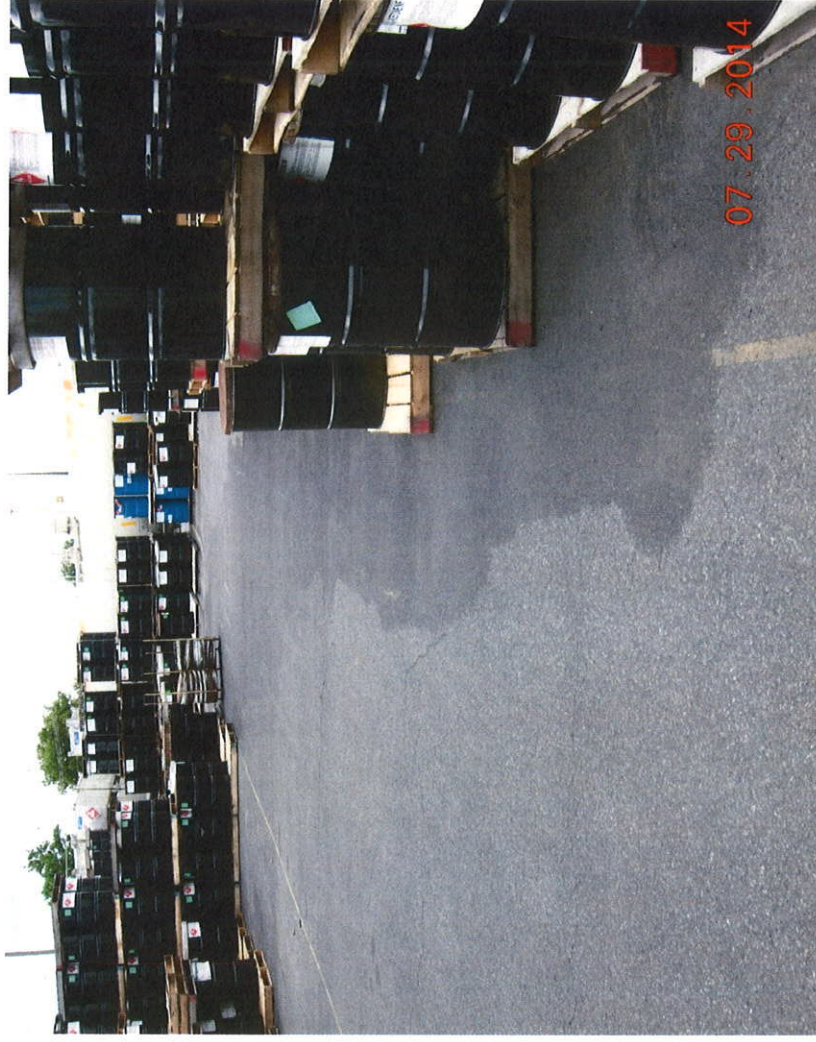
Photograph #15

Second spill on pavement near large number of black drums.

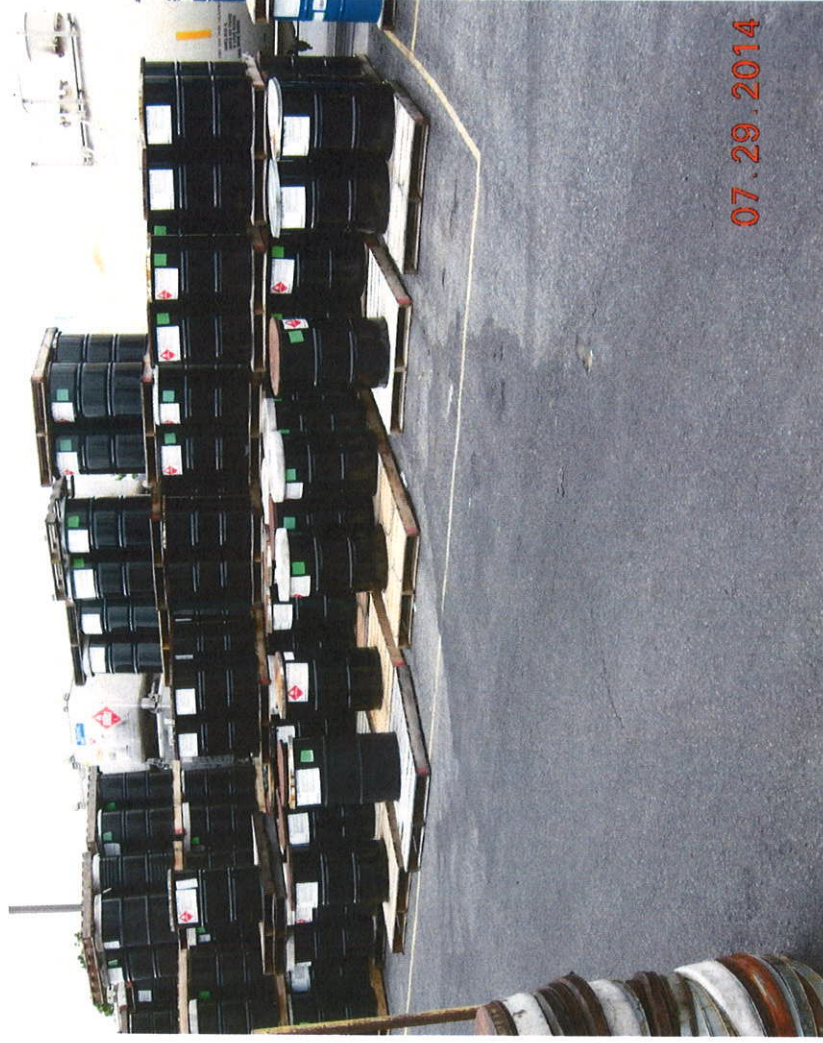
Photograph #16
Second photograph of spill on pavement
nearby large group of black drums.

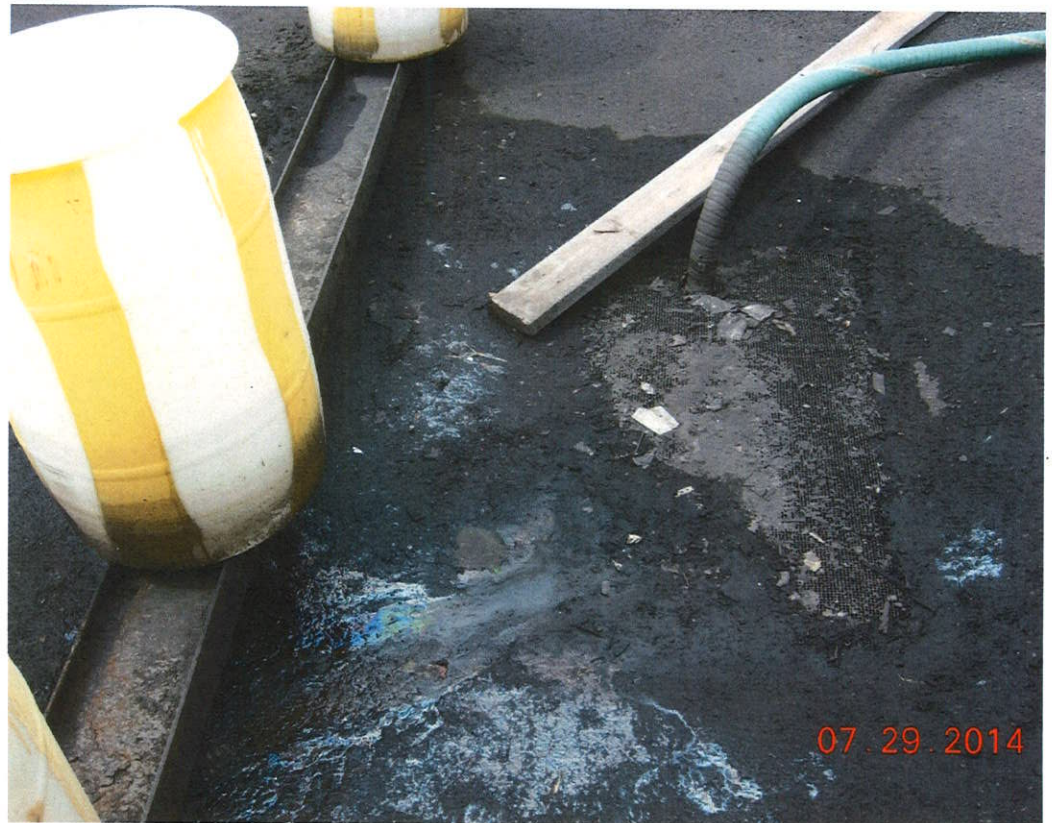
Photograph #17

Sump area in low segment of rear portion of facility showing noticeable oily sheen on the ground.

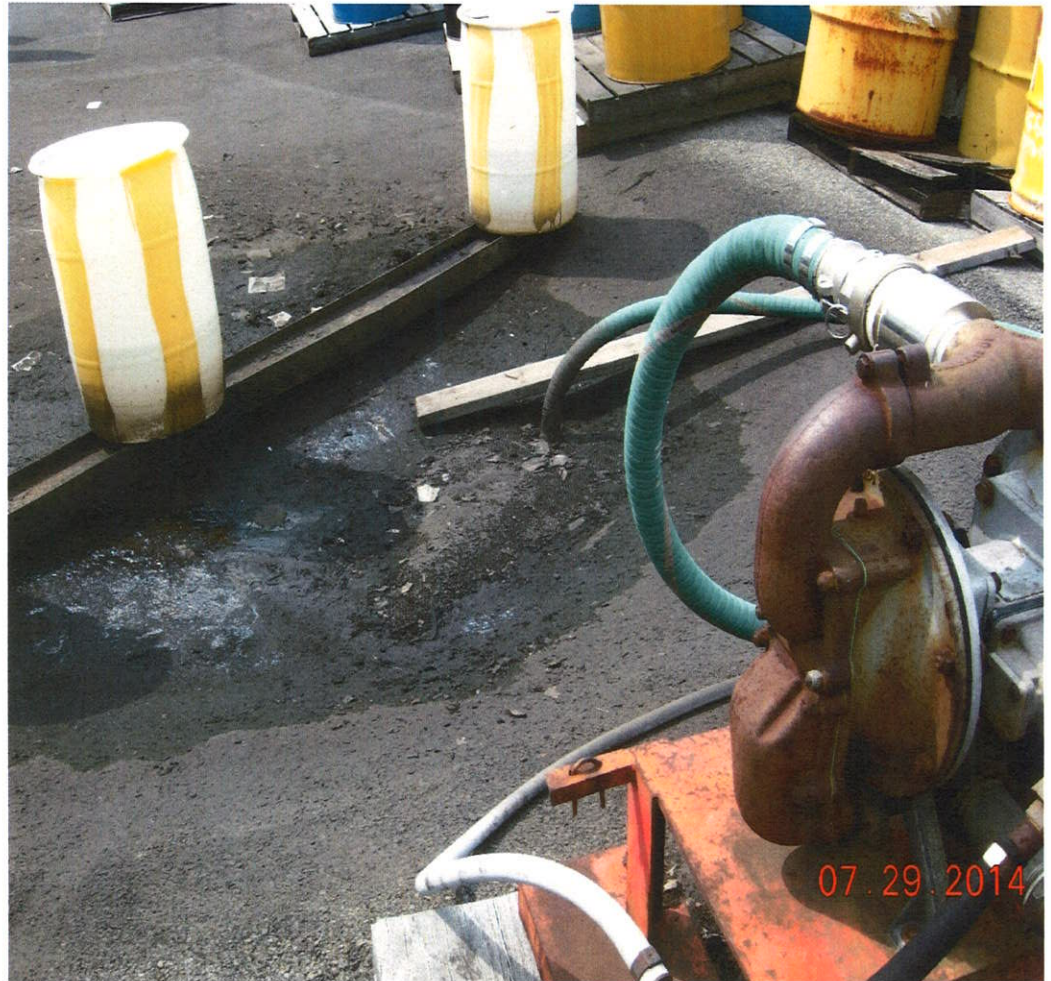
Photograph #18

Second photograph of sump area with nearby pump used for draining accumulated liquids.

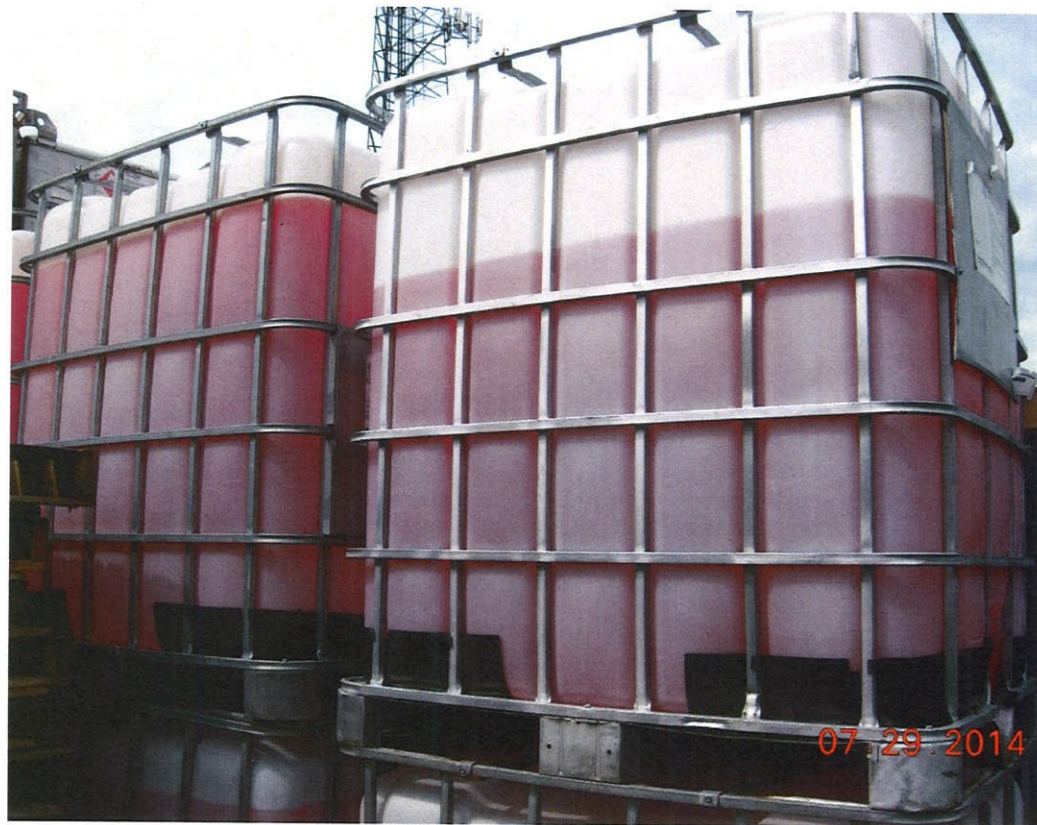
Photograph #19

A pink liquid in these large totes was described as potassium permanganate by facility staff.

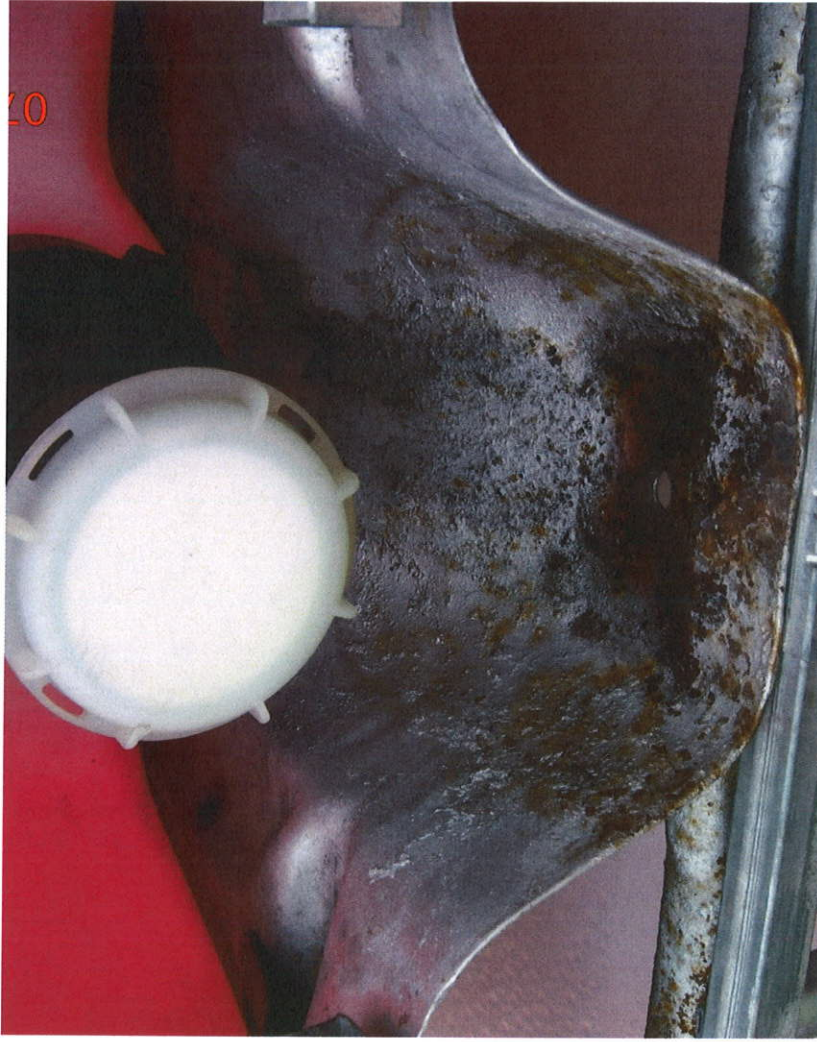
Photograph #20

The solution was leaking from one of the
totes and dripping on to the ground nearby.

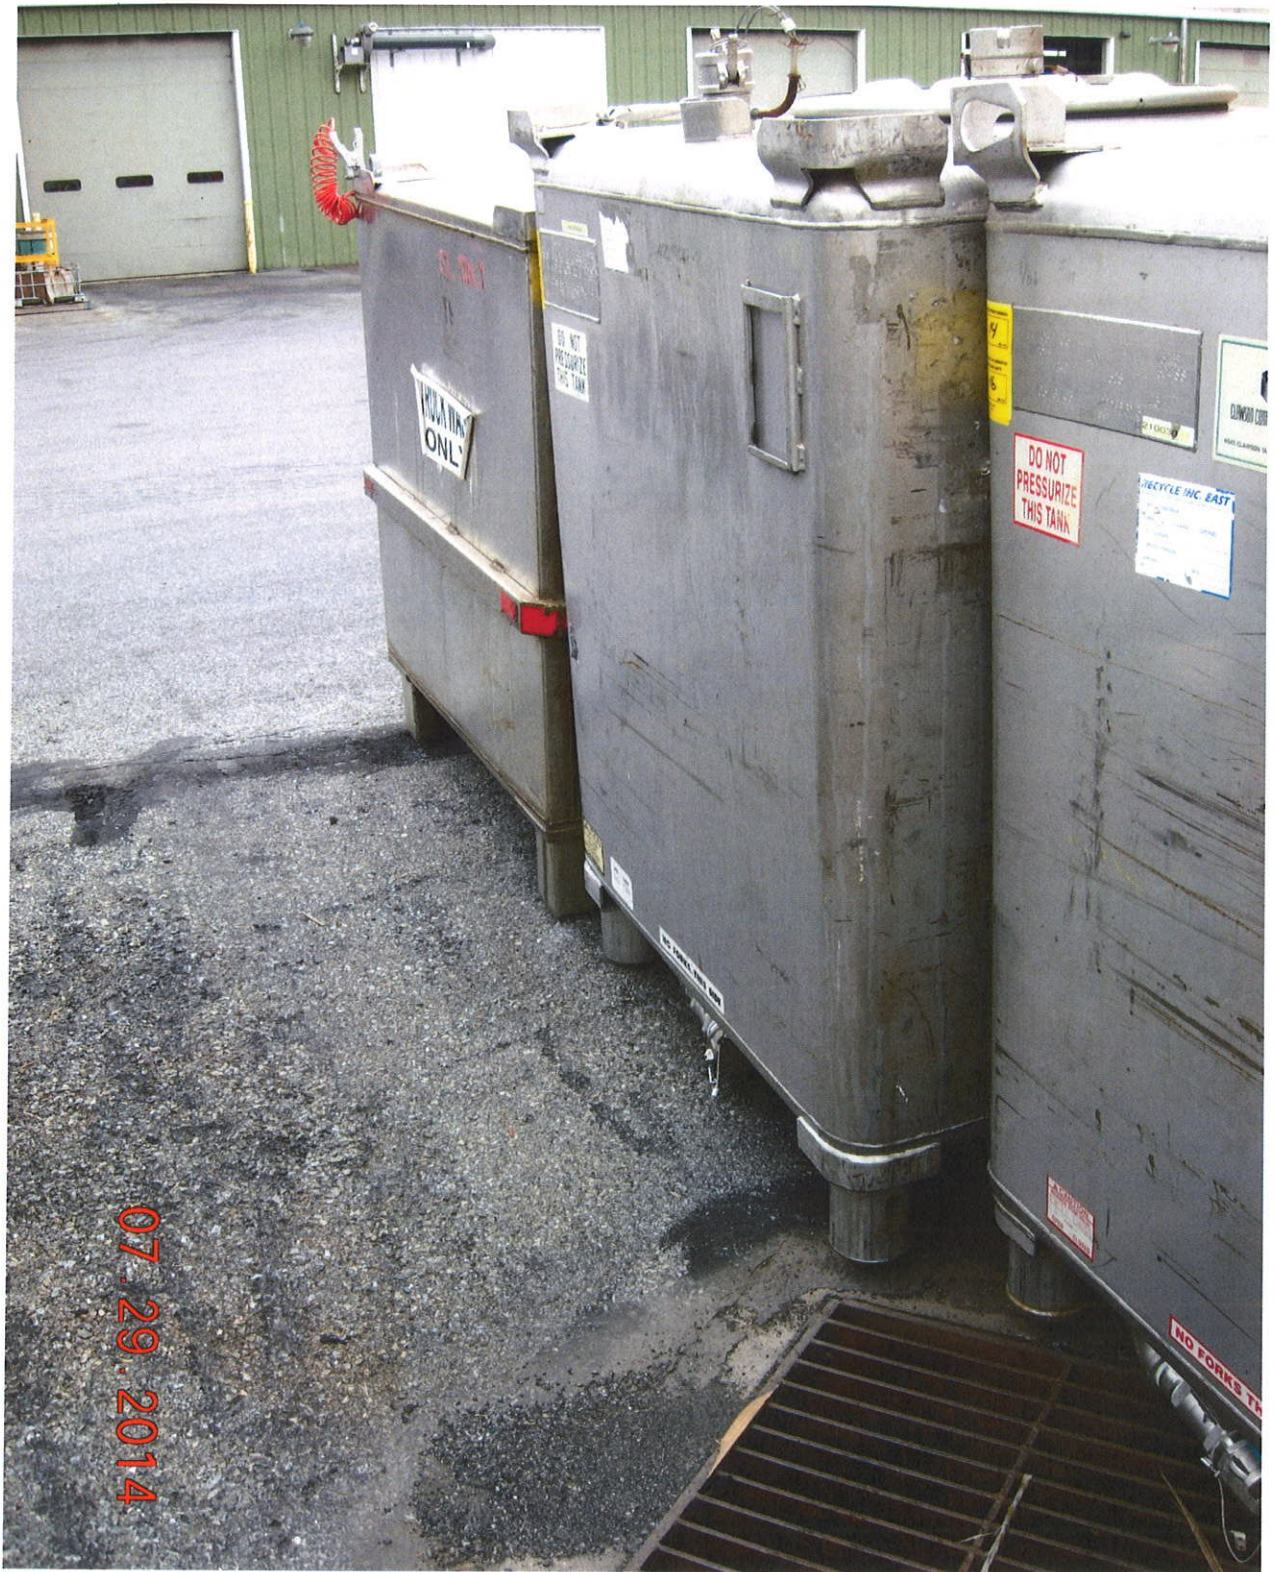
The inspectors also observed a tote that were placed right on top of a storm drain (**Photograph #21 & #22**). The placement of the totes in this manner adjacent to and also directly over a storm drain clearly shows bad management practices. In addition, since this container has a capacity well over 55 gallons, it is a 90-day container and facility staff should be inspecting it weekly. There were no records produced by facility staff that indicated that this area was ever inspected as part of the weekly inspections. Brenntag staff explained that the storm drains in this part of the facility flow directly into nearby Willow Creek. Willow Creek is a tributary of the nearby Schuylkill River (**See Attachment #2, Aerial Map of Brenntag**). In the facility's maintenance area, there were universal waste bulbs that were not dated and were not stored properly (**Photograph #23**). The facility staff were not maintaining a data base on the accumulation. Two used bulbs were also loose, and not placed in any container.

Photograph #21 – Three totes placed near storm drain

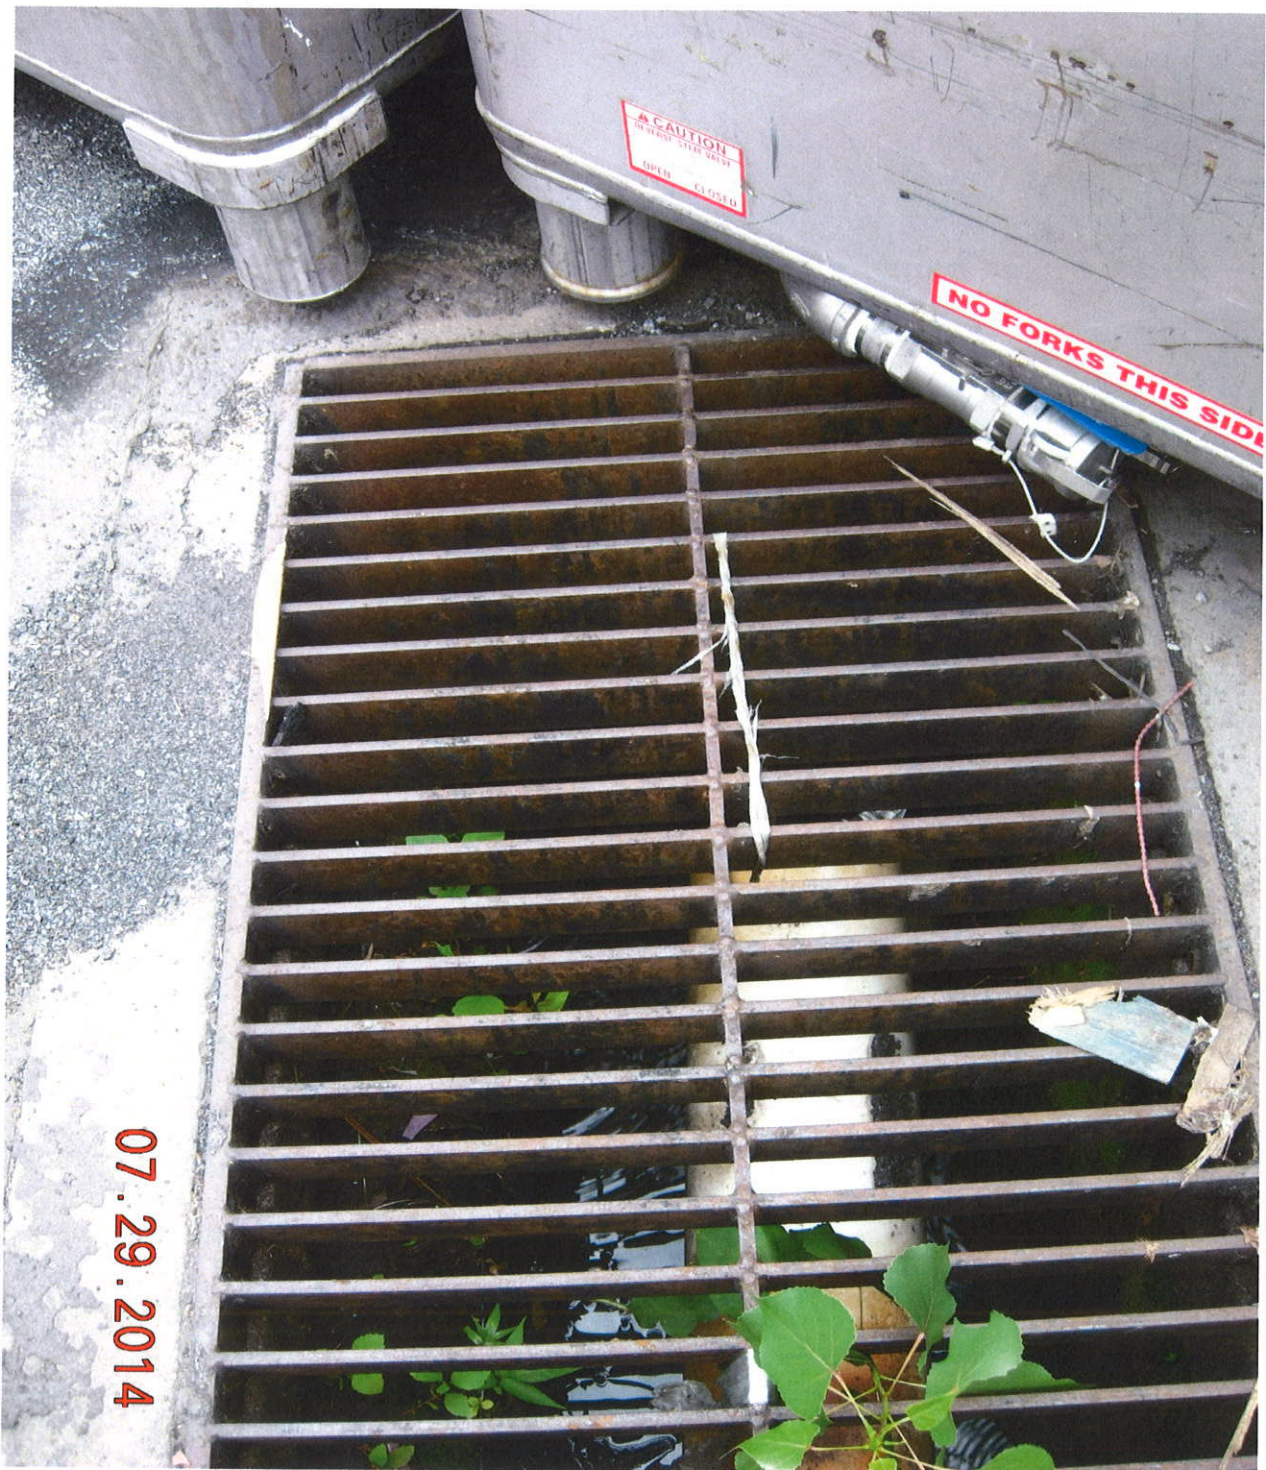
Photograph #22 – Hazardous Waste tote place on top of storm drain, two other totes are adjacent to it.
